# National Transportation Safety Board

## Marine Accident Brief

### *Collision between M/V Maersk Wisconsin and Tug and Barge Unit in Kill Van Kull*

<b>Accident no.</b>	DCA-12-LM-003
<b>Accident type</b>	Collision
<b>Vessels</b>	Containership <i>Maersk Wisconsin</i> and tug and barge unit <i>Ruth M. Reinauer</i> and <i>RTC 102</i>
<b>Location</b>	Kill Van Kull, near Bergen Point, New Jersey 40°38.9' N, 74°08.5' W
<b>Date</b>	December 5, 2011
<b>Time</b>	0213 eastern standard time (universal time coordinated – 5)
<b>Injuries</b>	None
<b>Property damage</b>	\$295,000
<b>Environmental damage</b>	None
<b>Weather</b>	Widespread fog, 3–5 mph south winds, visibility about 0.25 mi., air temperature 44° F
<b>Waterway characteristics</b>	<b><i>Kill Van Kull:</i></b> 3-mile-long tidal strait between Staten Island, New York, and Bergen Point, New Jersey <b><i>At accident location:</i></b> about 1,150 ft. wide, controlling depth 45 ft., current speed 0.9 knots, direction 274° true

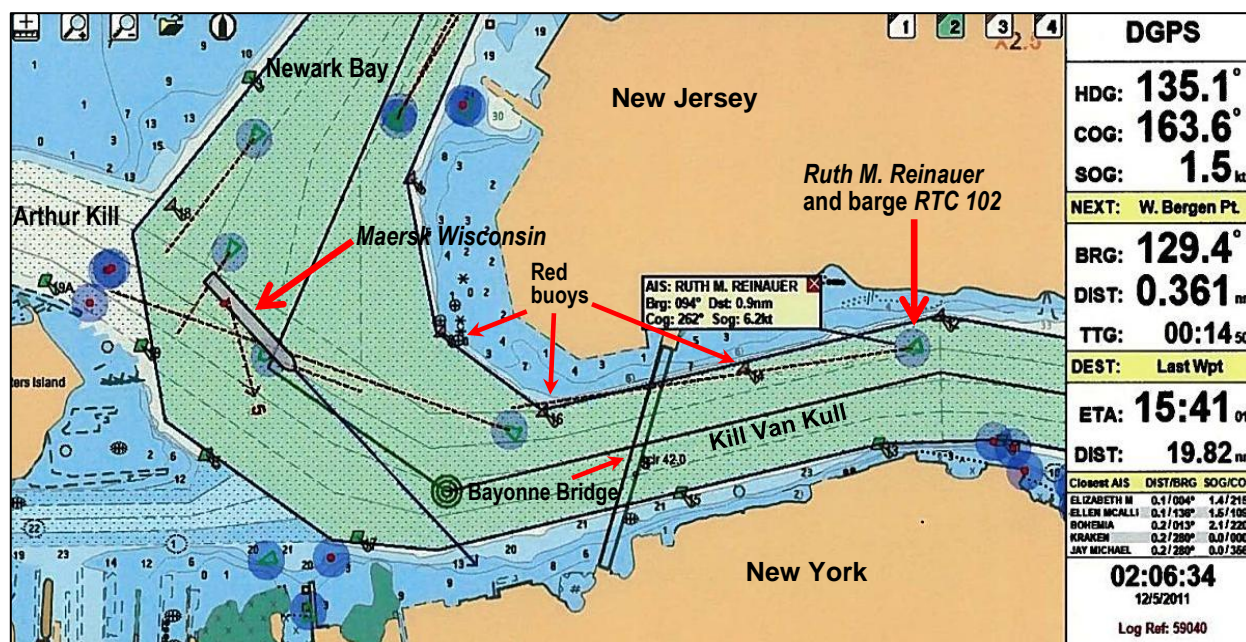
Screen image obtained from a pilot's laptop computer on board the *Maersk Wisconsin* with labels added indicating landmarks and waterways as well as vessel positions about 7 minutes before the collision.

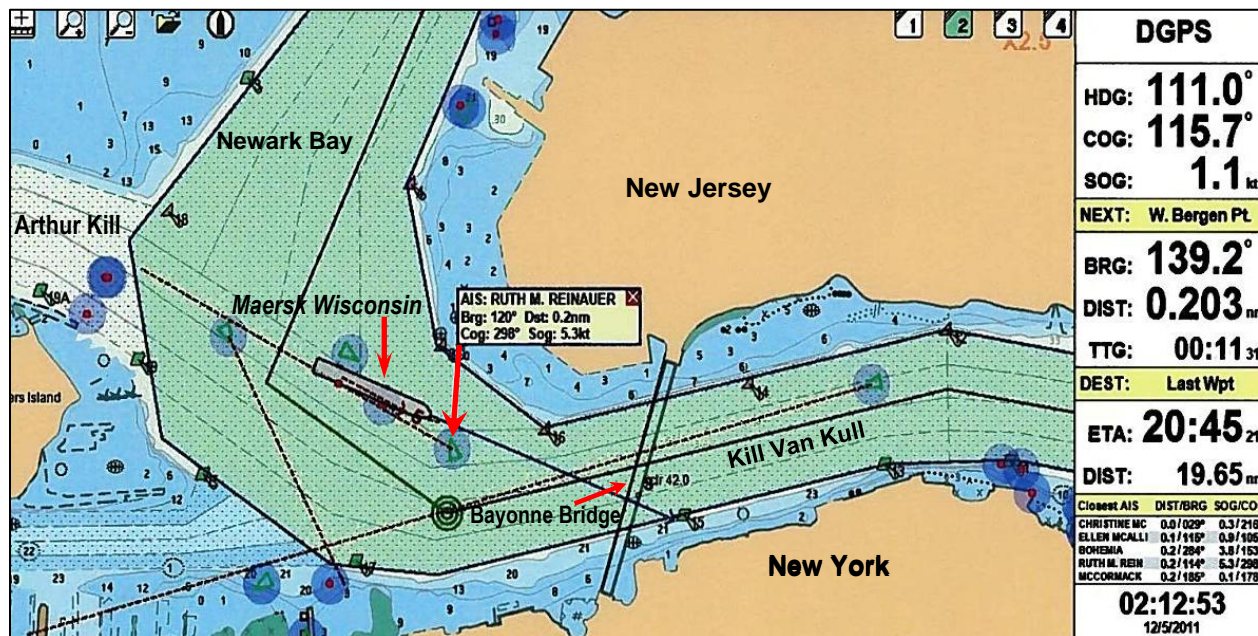
Less than a minute later, the *Ruth M. Reinauer* mate radioed, “Hey captain, have your tugs push you away” but received no reply. On the *Maersk Wisconsin*, the pilot ordered, “Start thrusters and [engine] full astern.” The mate of the *Ruth M. Reinauer* attempted to use engines to maneuver his vessel to avoid a collision. About 0213, the bow of the *Maersk Wisconsin* contacted the port side midships of the barge *RTC 102*. At the time of the collision, the speed of the *Maersk Wisconsin* was less than 1 knot, and the speed of the *Ruth M. Reinauer* was about 5 knots.

Screen image from a pilot's laptop computer on board the *Maersk Wisconsin* showing position and navigational data at the approximate time of collision.

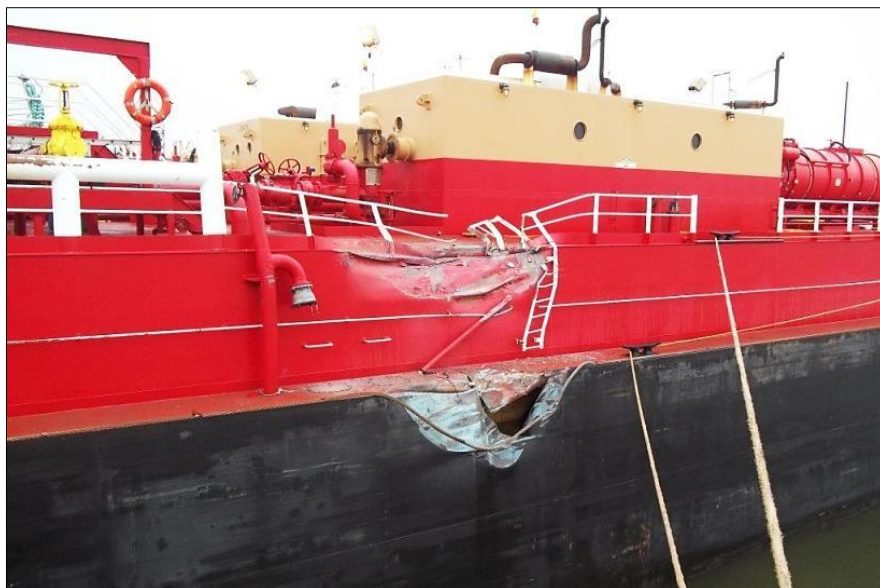
Both the containership *Maersk Wisconsin* and the barge *RTC 102* were damaged in the collision. On the *RTC 102*, two port side ballast tanks were holed at the deck level and sustained side shell plate damage and upset of internal framing. Some frame and plate damage was also noted in a cargo tank.

Portside damage to the *RTC 102*.

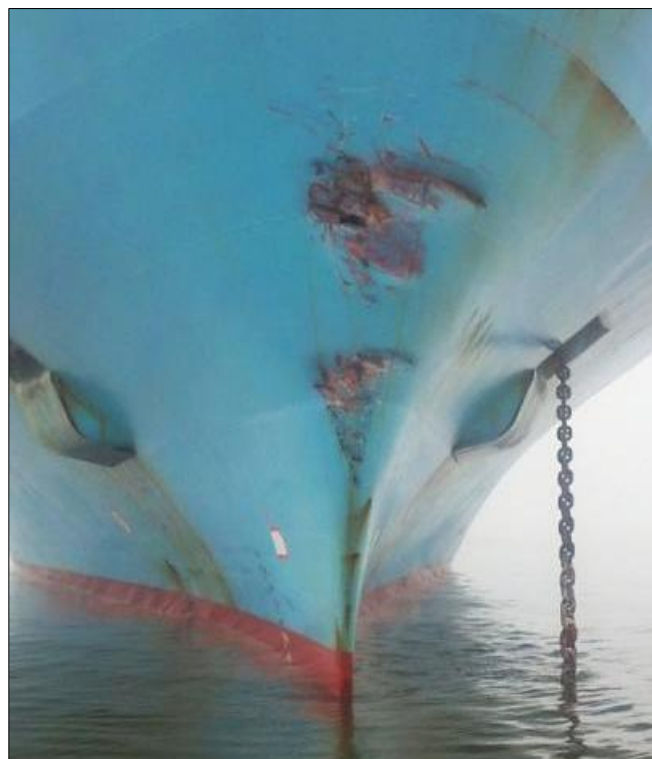
The bow of the *Maersk Wisconsin* (fore peak void) sustained shell plate damage and was holed about 23 feet above the waterline. Internal framing of that compartment was also distorted.

Damaged bow of the *Maersk Wisconsin*.  
Photo by US Coast Guard
